ARMY AIRCRAFT SAFETY PERFORMANCE REVIEW
DOCUMENT IDENTIFICATION
DEC 1992

Army Aircraft Safety Performance

FY
87
through
FY
91

UH-60
OH-58D
AH-64
MH/CH-47D

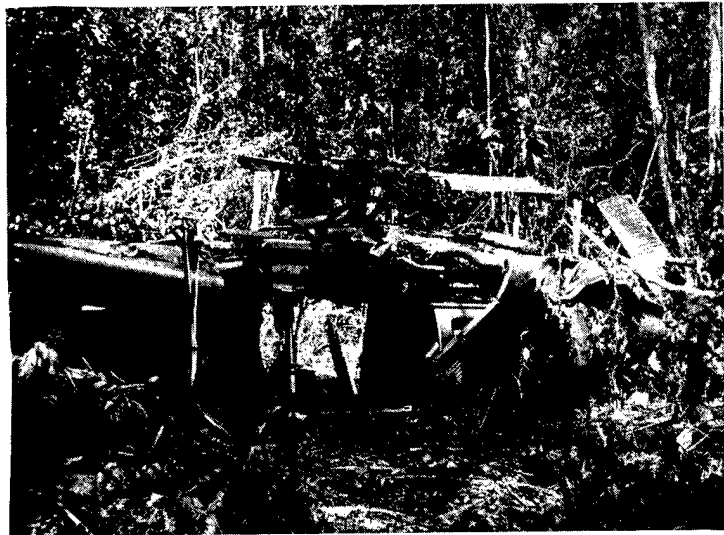
Materiel failure

The aircraft was taking off from a confined area. As the pilot added power, the number 1 power turbine wheel in the number 1 engine failed. Due to low airspeed and high gross weight, number 2 engine power available was insufficient to maintain flight. The aircraft settled into the trees.

Cause: The engine failed due to debonding and loss of portions of the shroud segment honeycomb and filler material in the turbine case. This created an uneven surface on the stator honeycomb, which disrupted airflow around the gas generator rotor blade tips. This created a resonance frequency and stress, which caused cracking in the blade root and subsequent fracturing of the blades. Contributing to the severity of the injuries was the fact that troop seats and restraint systems had been removed from the aircraft.

Cause: Failure of number 1 turbine at an altitude, airspeed, and gross weight where single-engine power was insufficient to maintain flight.

Recommended actions: *Higher level:* Inform all assigned of this accident and provide restraint systems and seats for all occupants. *Army level:* Accelerate the application of MWO 55-2840-248-5032 for all T700-GE-700 engines, which will add a damper to the turbine blades. Develop an engine-vibration inspection to identify engines with excessive resonance-frequency vibrations.

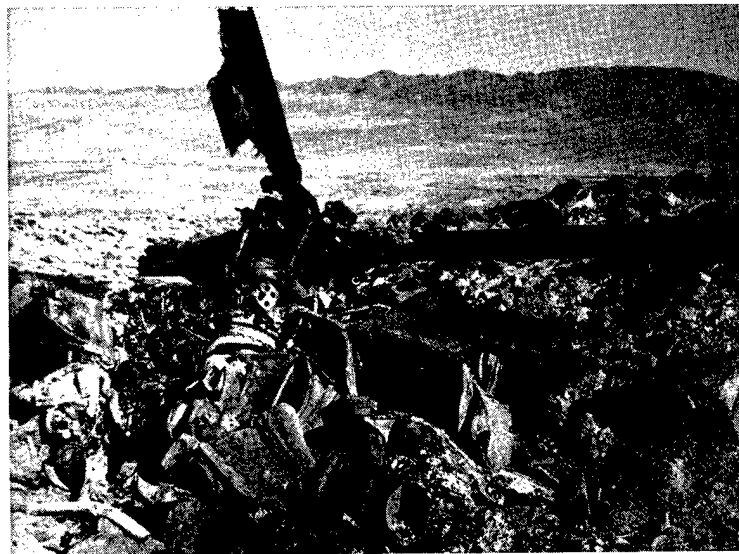
Failure to maintain terrain clearance

Result: Four fatalities, a destroyed aircraft, and a cost of \$8,048,397.

Cause: The crew failed to maintain terrain clearance. The most probable reason for this failure is that either the crew was overconfident in their ability to fly low and fast without striking obstacles, or the crew's attention was drawn to something inside the cockpit. Because of the high airspeed at low altitude, the crew had less reaction time to avoid obstacles.

Cause: Failure to maintain terrain clearance while flying low and fast.

Recommended actions: Discuss tactical flight procedures for desert and mountainous terrain, as written in TC 1-201, with emphasis on terrain flight techniques, aircrew responsibilities, navigation, and aircraft performance and handling.

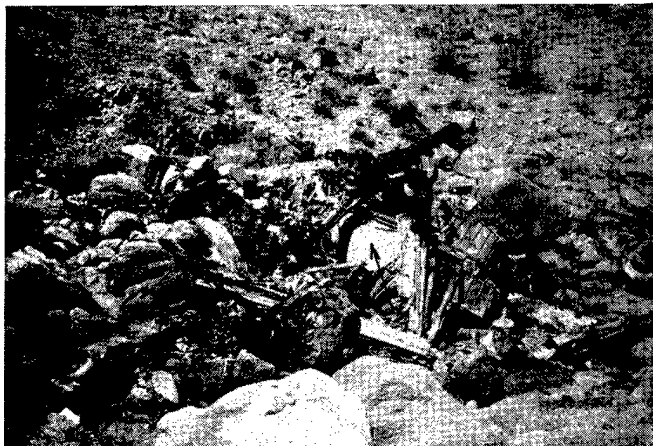
Poor cockpit coordination

During night terrain flight at 70 knots and 20 feet agl, the master caution light and an undetermined segment light came on. The IP took the controls and subsequently struck a large boulder. The aircraft cartwheeled and came to rest in an upright position.

Cause: Poor cockpit coordination and excessive command pressure.

Cause: This accident resulted from a combination of factors, one of which was lack of cockpit teamwork. The attention of the IP and the PI, both of whom were using NVGs, was probably drawn inside the cockpit when the master caution light illuminated. But just as causal was the command climate of excessive pressure within the unit. The unit's aircrew training program was not being conducted in accordance with AR 95-1. The NVG mission was being flown by an IP who was not current in NVG flight and a pilot who was not unit mission qualified.

Recommended actions: *Higher level:* Inform subordinate commands of the facts surrounding this accident, with emphasis on cockpit coordination during NVG operations. *Army level:* DA advise all commands of the importance of understanding aviation unit capabilities and limitations to preclude overcommitment of aviation resources.

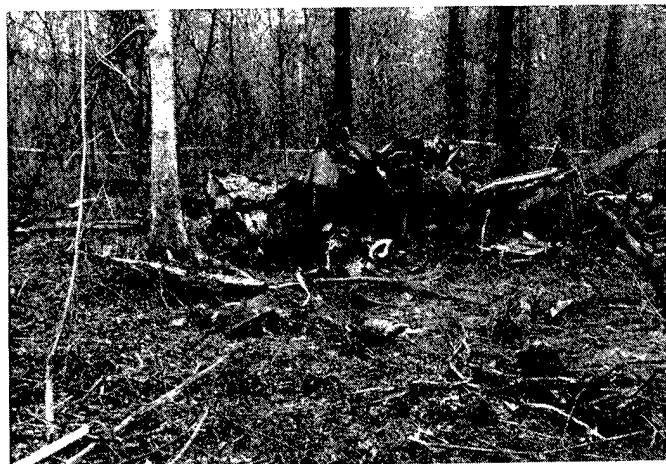
Cause: The lead UH-60 was flight following with unit operations, while the single UH-60 was flight following with the post facility. There was no require-

ment for the aircrews to make position reports on a common frequency, which would have alerted both accident UH-60s of their merging course. Contributing to this accident were the visual limitations associated with NVGs and the restricted field of view of UH-60 front and side windows.

Cause: Aircrews failed to see and avoid each other due to equipment design and flight-following procedures.

Recommended actions: *Higher level:* Establish flight-following procedures on a common frequency that requires position reporting. *Army level:* Improve the field of view of UH-60 pilot/copilot windscreen, side windows, and gunner's door windows.

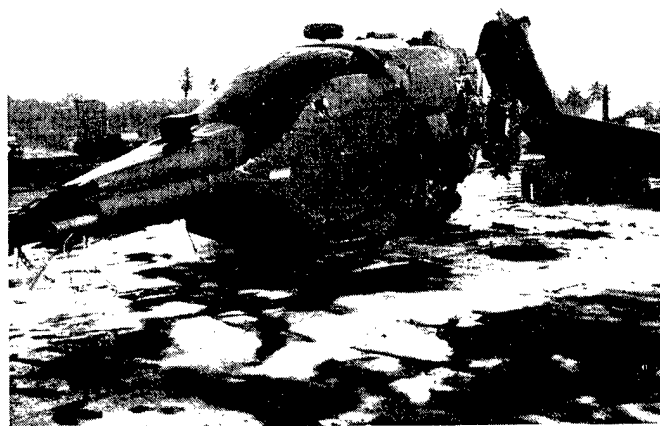
Cause: The crews of the two aircraft failed to see each other in time to avoid the collision. The IP of aircraft #1 was not adequately trained to perform the duties of NVG IP. As a result, he became task saturated and forgot to call out of parking and taking the runway. His lack of radio calls precluded the crew of the UH-60 hovering down the runway from knowing that there was any traffic on the runway.

Cause: Pilot failed to alert other aircraft of his intentions.

Recommended actions: Ensure that NVG IPs receive proper unit training in accordance with FM 1-219 and that crew chiefs/observers are adequately trained in clearing their aircraft of hazards.

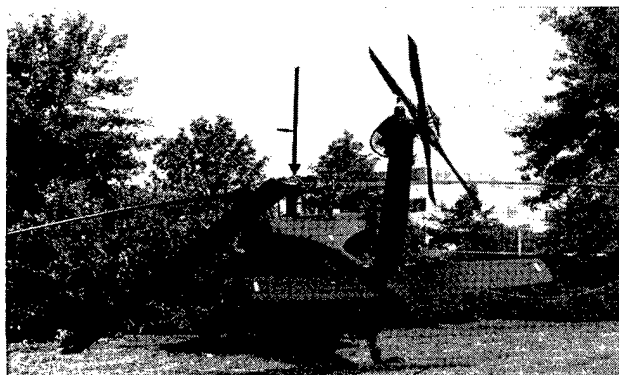
Cause: Pilot chose wrong course of action for a stabilator malfunction.

lack of confidence in aircraft performance, and lack of knowledge of stabilator manual mode operations.

Recommended actions: Provide additional instruction to the IP on the capabilities of the UH-60 with the stabilator in a fixed position.

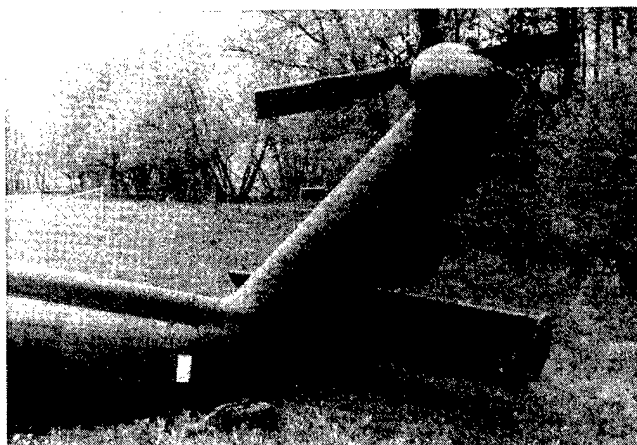
Tail rotor drive shaft failure

Cause: The transmission blower shaft retaining nut was improperly torqued by the manufacturer. This allowed the shaft to develop play, which eventually caused the flange splines to fail.

Cause: Failure of the transmission blower shaft splines.

Recommended actions: Army level: Issue AVUM units a flex boroscope so that a complete inspection of the drive shaft can be made.

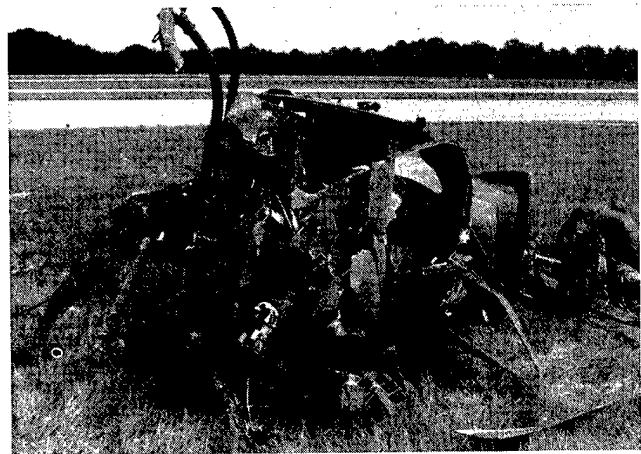
Cause: The IP's actions resulted from a combination of factors that culminated in spatial disorientation. He was self-medicating an aggravated vestibular condition that made him susceptible to spatial disorientation. Although current, the IP was only marginally proficient with NVGs. He had flown with NVGs only 4.9 hours in the previous 4 months.

Cause: Spatial disorientation.

Recommended actions: Unit level: Brief the accident and ensure all personnel are aware of the self-medication restriction in AR 40-8, with specific emphasis on the requirement to notify a flight surgeon before using over-the-counter drugs.

Army level: Initiate a study of Army aviators with increased risk for spatial disorientation and the associated flight risks that result from an aggravated vestibular condition.

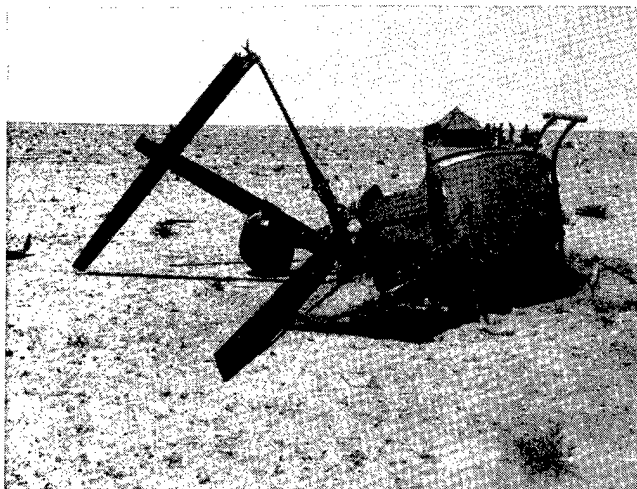
Engine failure

Cause: Engine failure followed by emergency landing in soft sand.

Recommended actions: *Unit level:* Emphasize that pilots should anticipate soft terrain when landing to unimproved areas. *Army level:* Consider changing the material of the Impeller and plain seal of the fuel boost pump. Consider Incorporating into the OH-58D transition program provisions for giving pilots some level of experience in minimum ground run landing. Evaluate current emergency procedures for in-flight failures of the fuel boost pump; consider whether "land as soon as practical" should be changed to "land as soon as possible." Consider relocating the lower nose-mounted wire cutter to allow more ground clearance.

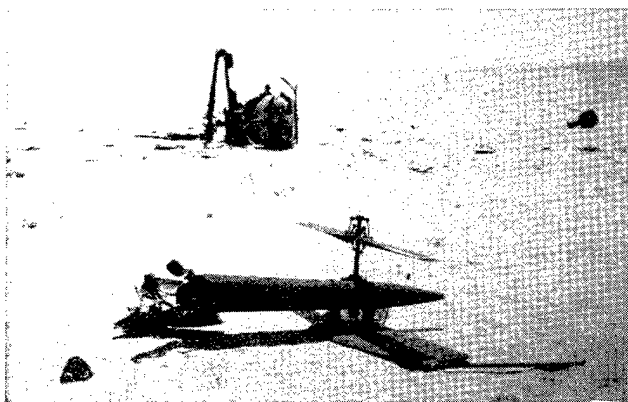
Cause: The crew failed to recognize rising desert terrain in their flight path due to (1) inadequate unit training in flying under night, aided, totally blacked out conditions; (2) haste to catch up with their sister element, resulting in their overflying the capability of their NVGs to provide adequate terrain definition under the totally blacked out desert conditions; (3) substandard NVGs, which placed the crew at a disadvantage in an already difficult situation; and (4) lack of a radar altimeter audio signal that would have warned the crew they were approaching critical proximity to the ground.

Cause: Failure to recognize rising terrain.

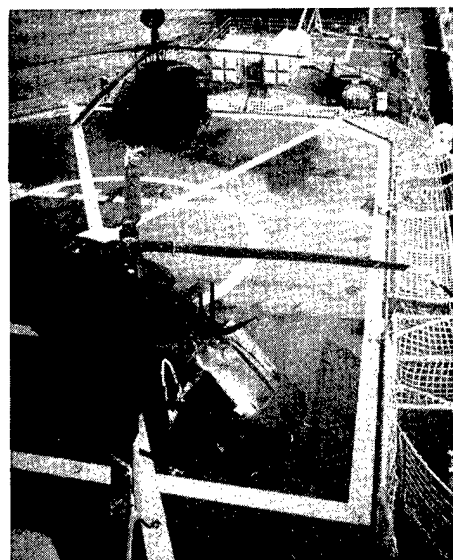
Cause: Overconfidence and inadequate procedures.

Recommended actions: *Unit level:* Inform all personnel of the circumstances of this accident, with emphasis on how overconfidence contributed. *Higher level:* Establish procedures for making decisions to allow simultaneous dual-aircraft operations from ships whose flight decks have been designated as single-spot decks.

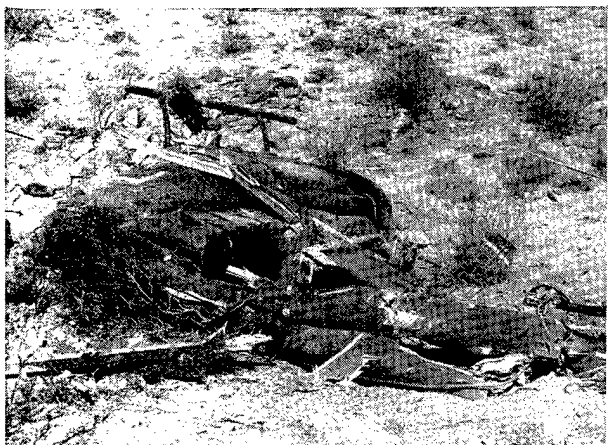
During night tactical training with ANVIS-6 NVGs in use, the low-fuel caution light illuminated. The aircraft was flown another 6 minutes and landed at a lager site, where it was shut down about 10 minutes later. The aircraft was later started and departed the lager site with the low-fuel caution light illuminated and 52 to 58 pounds of fuel on board. About 1

Cause: Failure to follow procedures.

minute into the flight, during a slow right turn at 50 knots and 100 to 200 feet agl, the engine quit. The aircraft was autorotated and landed in a rocky area. The left skid settled atop a large rock, and the aircraft rolled to the right, destroying the rotor system and causing major damage to the aircraft. There were no injuries.

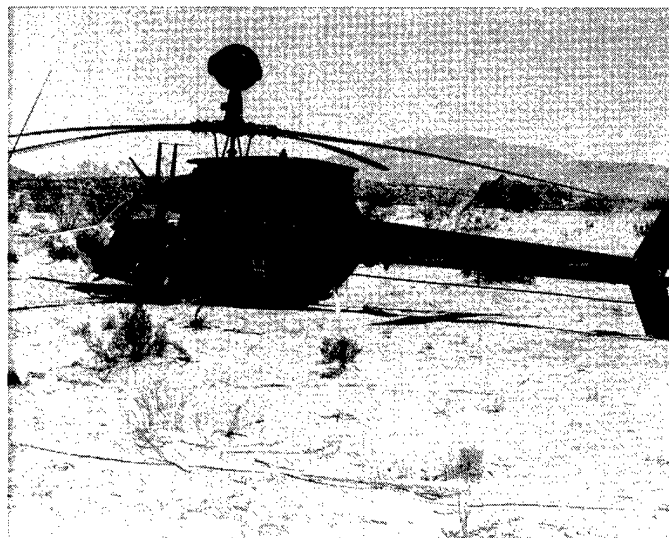
Cause: Loose "B" nut that connects fuel hose to fuel boost pump.

Recommended action: *Army level:* Issue a safety-of-flight message to the field requiring a one-time inspection of all fuel system "B" nuts attaching fuel hoses to the fuel boost pumps in the OH-58D.

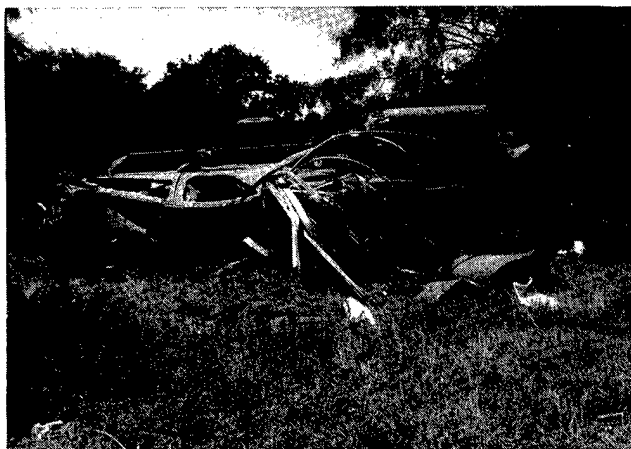
Cause: Loss of engine power and inadequate crew coordination.

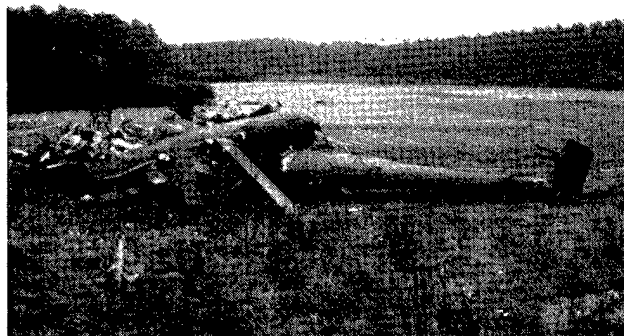
Cause: Crew failed to maintain clearance while crossing wires.

Recommended actions: Army level: Procure an obstacle-avoidance device for the AH-64 helicopter. This device should also be used in other tactical rotary-wing aircraft that commonly operate in terrain-flight mode.

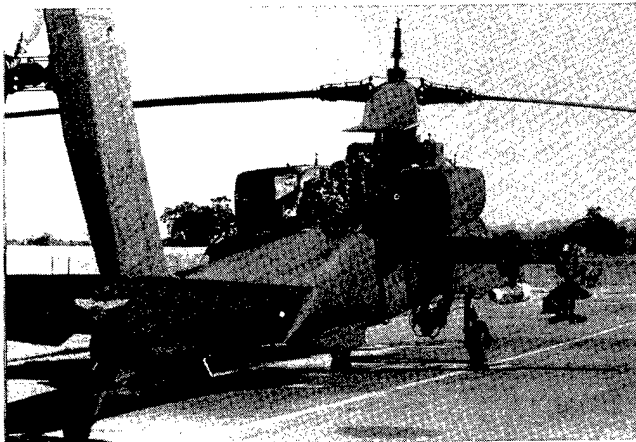
Cause: The cause of the rumbling noise was failure of the duplex bearing in the forward end of the power takeoff clutch. Suspected cause of the bearing failure is lack of lubrication.

Cause: Failure of duplex bearing in forward end of power takeoff clutch due to lack of lubrication.

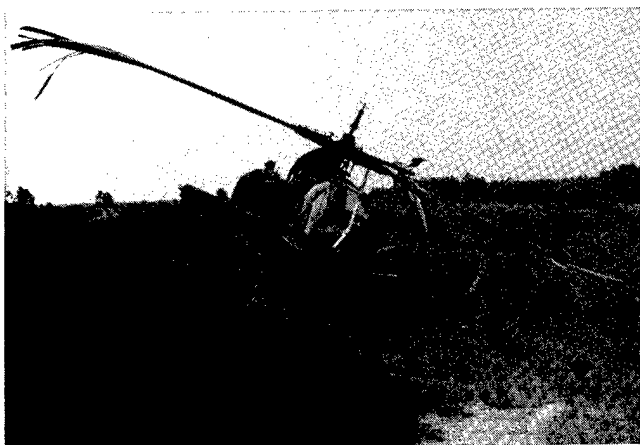
failure caused a loss of antitorque control. Without antitorque thrust, main rotor torque caused the aircraft to abruptly yaw right. Simultaneously, the aircraft descended, striking the ground on its left main gear. It slid laterally for 4 feet until it came to rest.

Cause: Crew failed to maintain a stabilized hover due to improper division of attention.

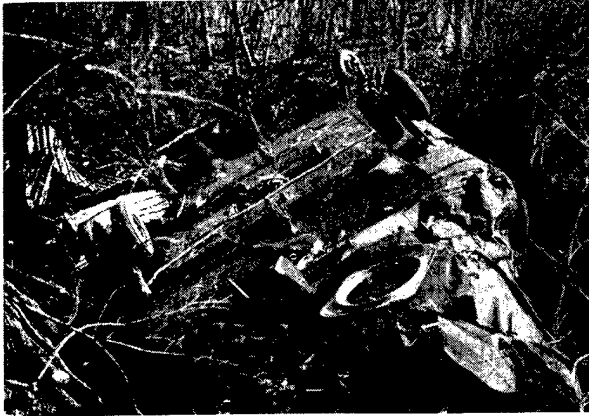
The CH-47D was on a day, low-level, VFR training mission with a slingload. While ascending a draw to cross a ridge, the aircraft entered a cloud layer and the crew lost visual ground reference. The crew initiated proper emergency procedures, but by the time contact was reestablished with the ridge, collision was unavoidable. The aircraft struck a 44-degree slope in a near-level attitude. Rotor blade contact with trees and the ground caused the aircraft to roll inverted and slide down the ridge about 120 feet.

Cause: Human error.

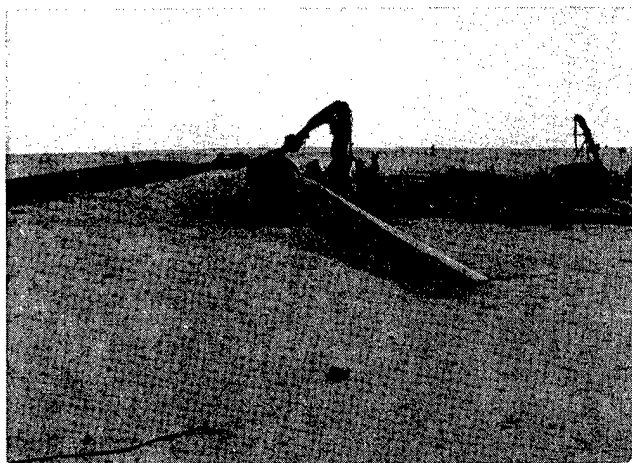
Cause: Failure of engine transmission pinion drive gear.

Recommended actions: Stress the importance of detailed crew and passenger briefings to ensure that, in the event of an emergency, all personnel understand their duties and all avenues of egress. Stress to all CH-47 crews the importance of providing all possible avenues of egress to passengers occupying vehicles on aircraft during tactical moves. Improve quality control in the manufacturing process of the identified defective gears used in CH-47D transmissions.

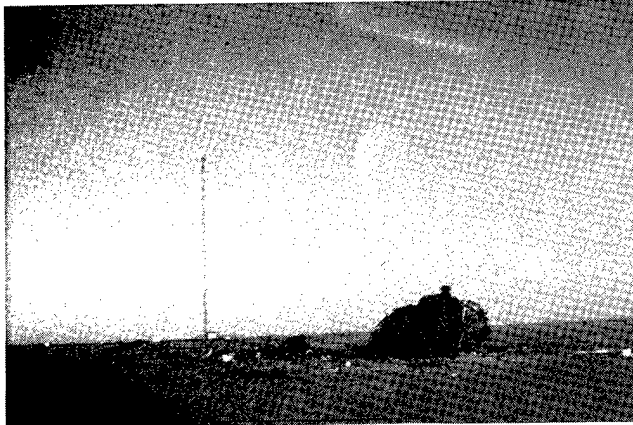
The aircraft was flying 250 feet agl at 120 knots at night along a prominent road. The crew failed to see a tower, which was marked on their map. The aircraft hit the tower 70 feet below the top and crashed. Four of five

Cause: Aircraft struck tower at night.

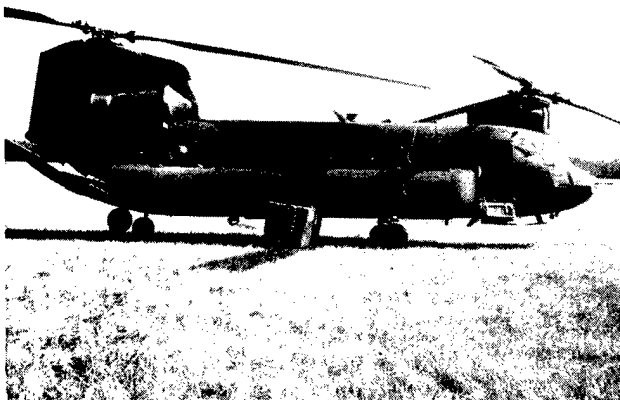
Cause: Failure to follow procedures.

Recommended actions: Emphasize how deviations from standards can result in crewmembers' attention being focused away from obstacle clearance.
